Test Report

No.: SHAEC23014476901

Sample Name: IC

Model No.: SOT23-5

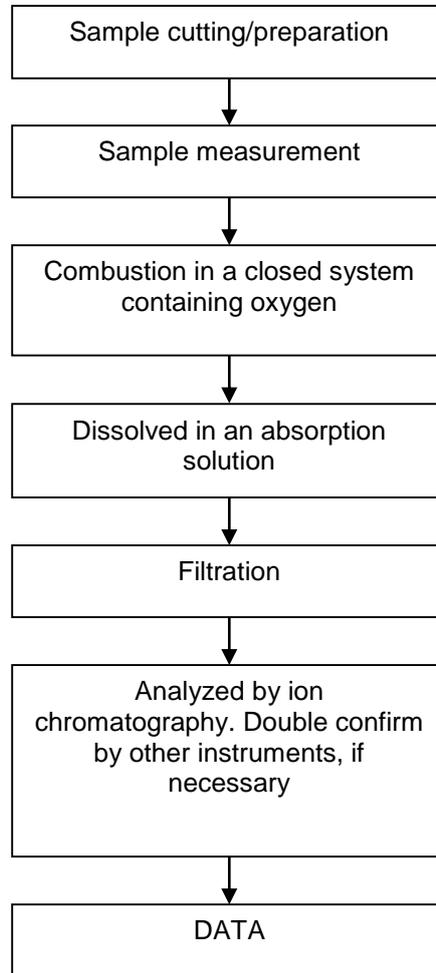
Halogen Testing Flow Chart

Test Method: With reference to EN 14582:2016, analysis was performed by IC.

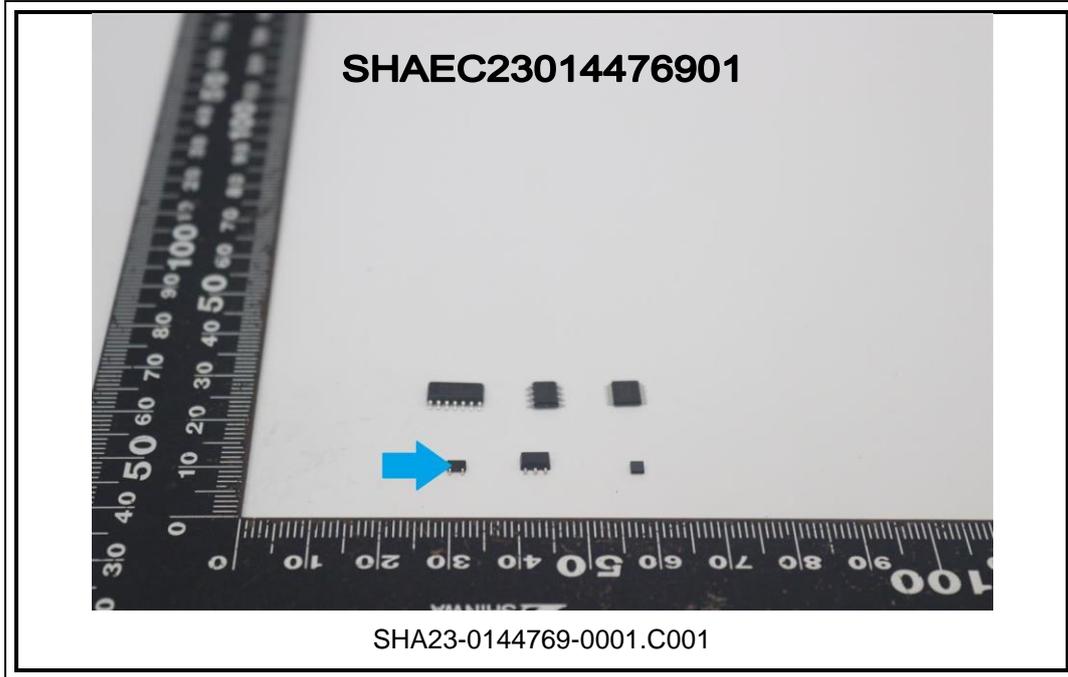
Sample Photo:

SN ID	Sample No.	SGS Sample ID	Description
SN1	A1	SHA23-0144769-0001.C001	Black body
